Analysis of the Pneumatic Burst of a Large Seamless Steel Pressure Vessel in Natural Gas Service

NBSIR 78-1589

Failure Analysis Report

December, 1978

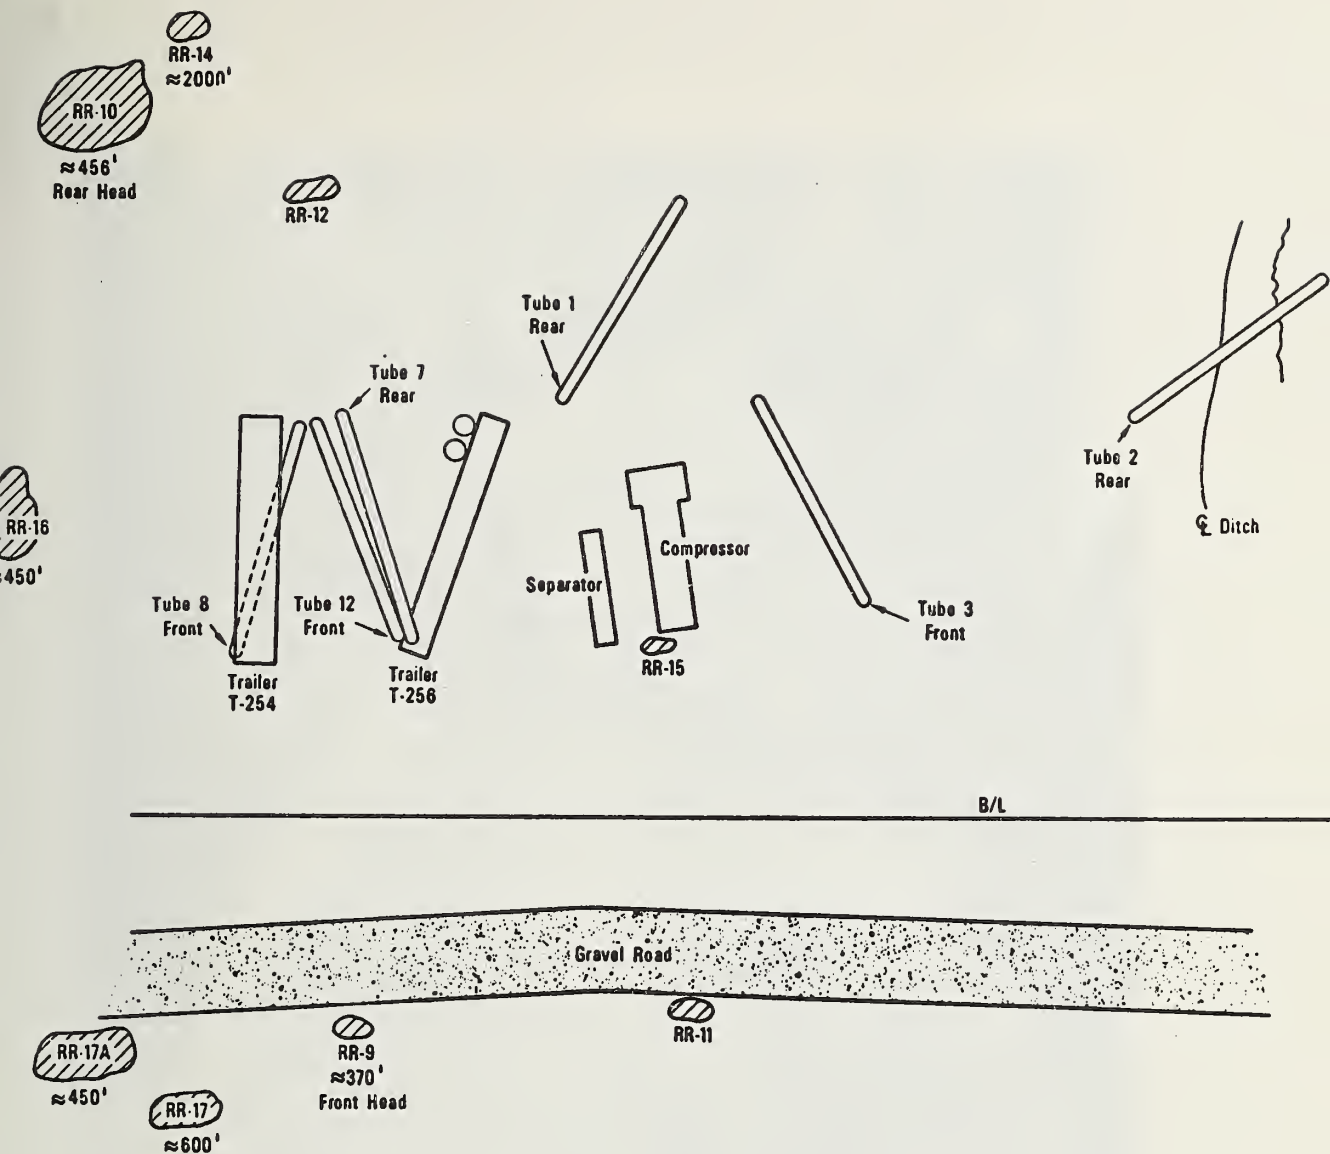
A diagram showing the incident site afterwards appears in Figure 1. The layout of the site itself was traced from a surveyor's diagram provided to NBS by the Kentucky State Fire Marshal's Office. The positions of the pieces of the burst cylinder were noted by Mr. Rodney Raby* of that office. The location of two pieces, RR-18 and RR-19 was not established.

Figure 1. Incident site after the pneumatic burst. Number by each piece indicates approximate distance from remains of trailer T-256, for those pieces for which this information was provided. The relative sizes of the pieces is indicated roughly by the size in the figure. The position of each piece was indicated by Mr. Rodney Raby of the Kentucky State Fire Marshal's Office. The positions of pieces RR-18 and RR-19 were not identified.

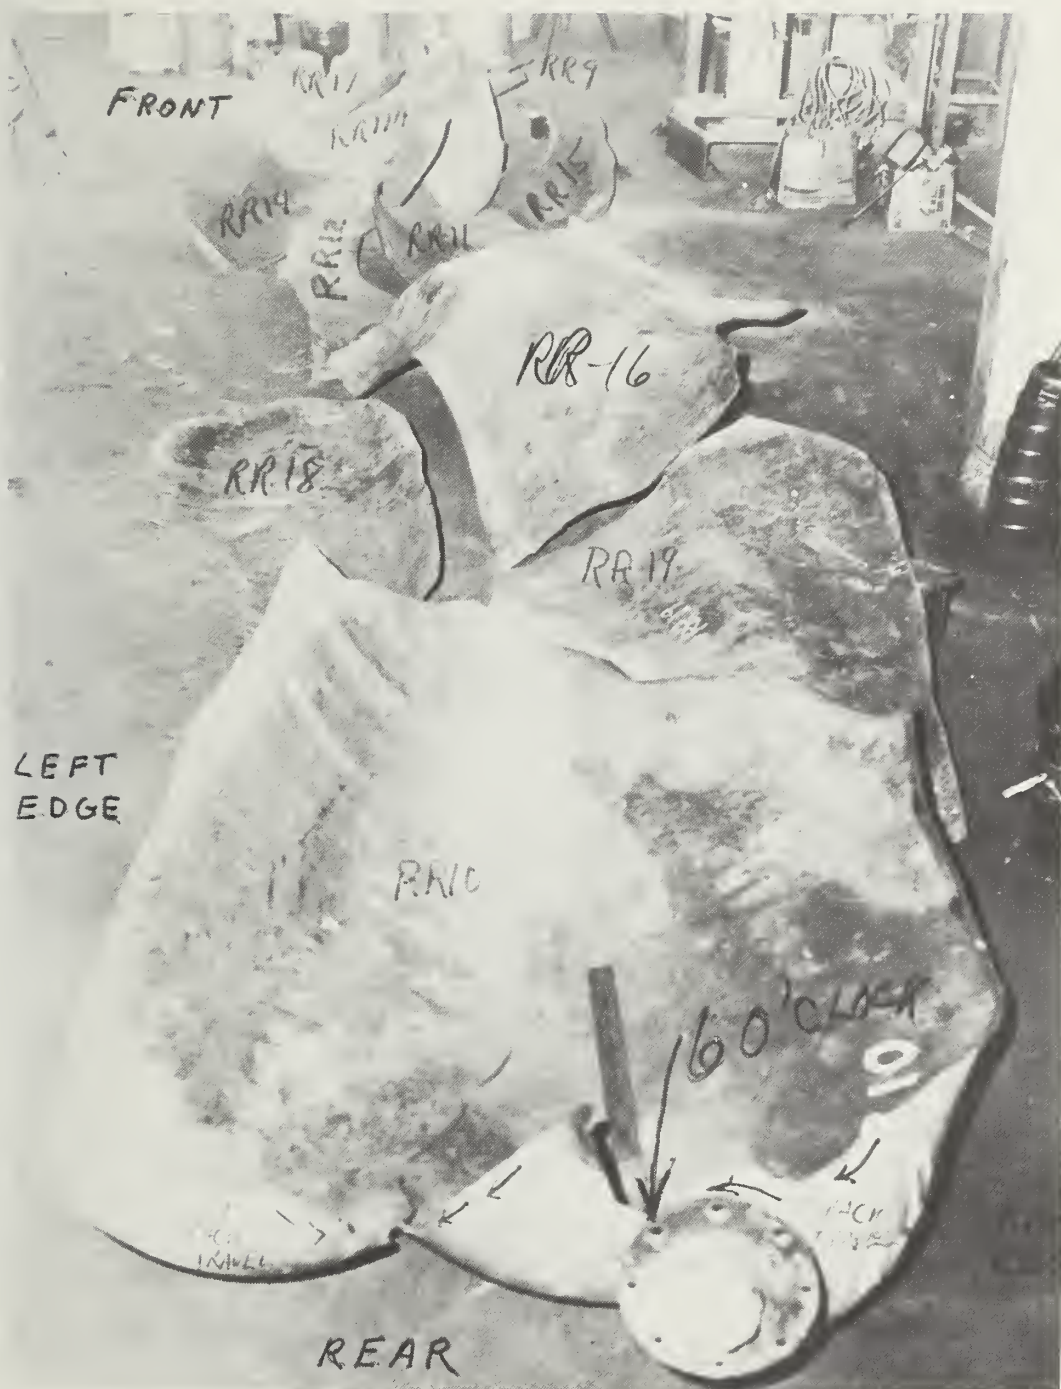
Review of color photographs of the pieces of cylinder 9959 and visual inspection of the pieces laid out as in Figure 2a did not reveal any signs of heating. Evidently, all pieces escaped significant heating from the fire which occurred shortly after the cylinder ruptured.

Figure 2a. Eleven pieces of cylinder 9959 laid out on the floor at Gladstone Laboratories, Inc. The rear head is in the foreground. (Photo courtesy of M. Bolinger, Jr., Gladstone Laboratories, Inc., Cincinnati, Ohio).

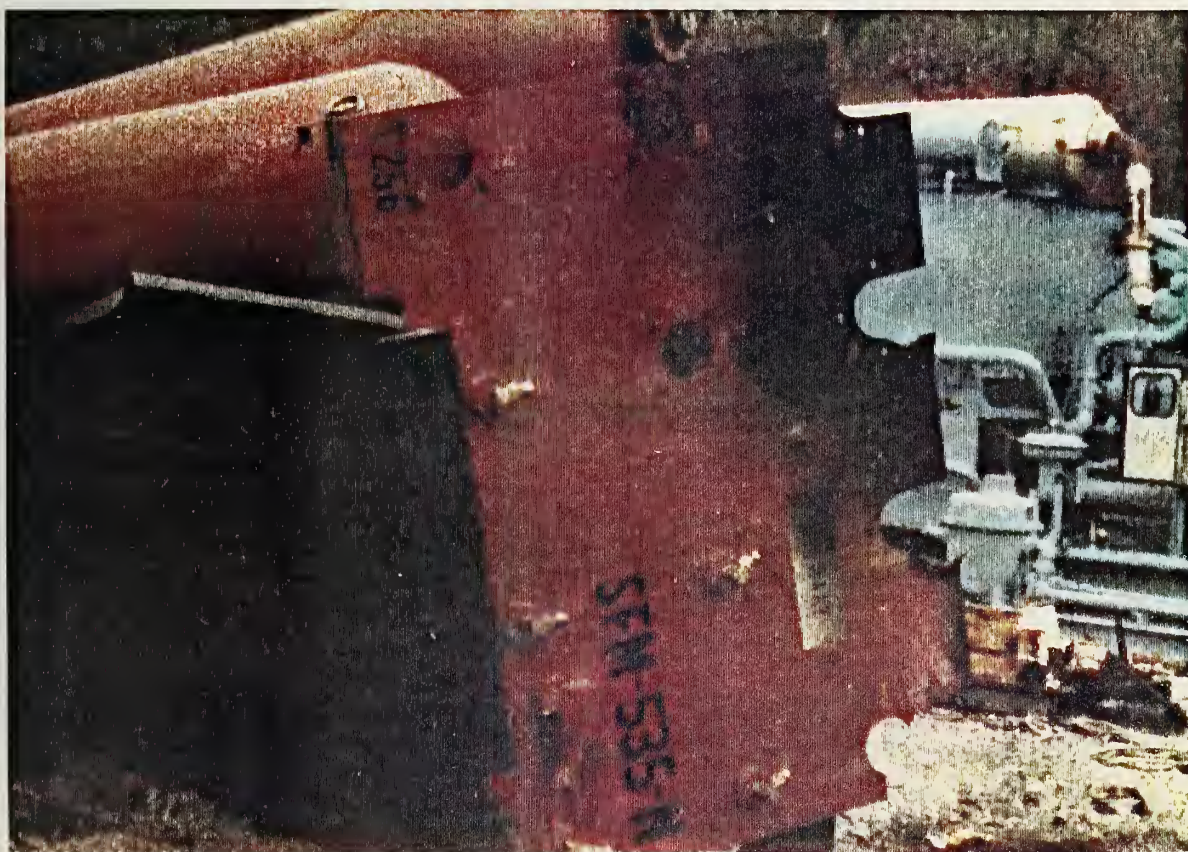
Figure 3. Remains of trailer T-256 after the incident, as seen from front. (Photo courtesy of Mr. W. Piehl, Western Sales and Testing, Inc., Amarillo, Texas.)

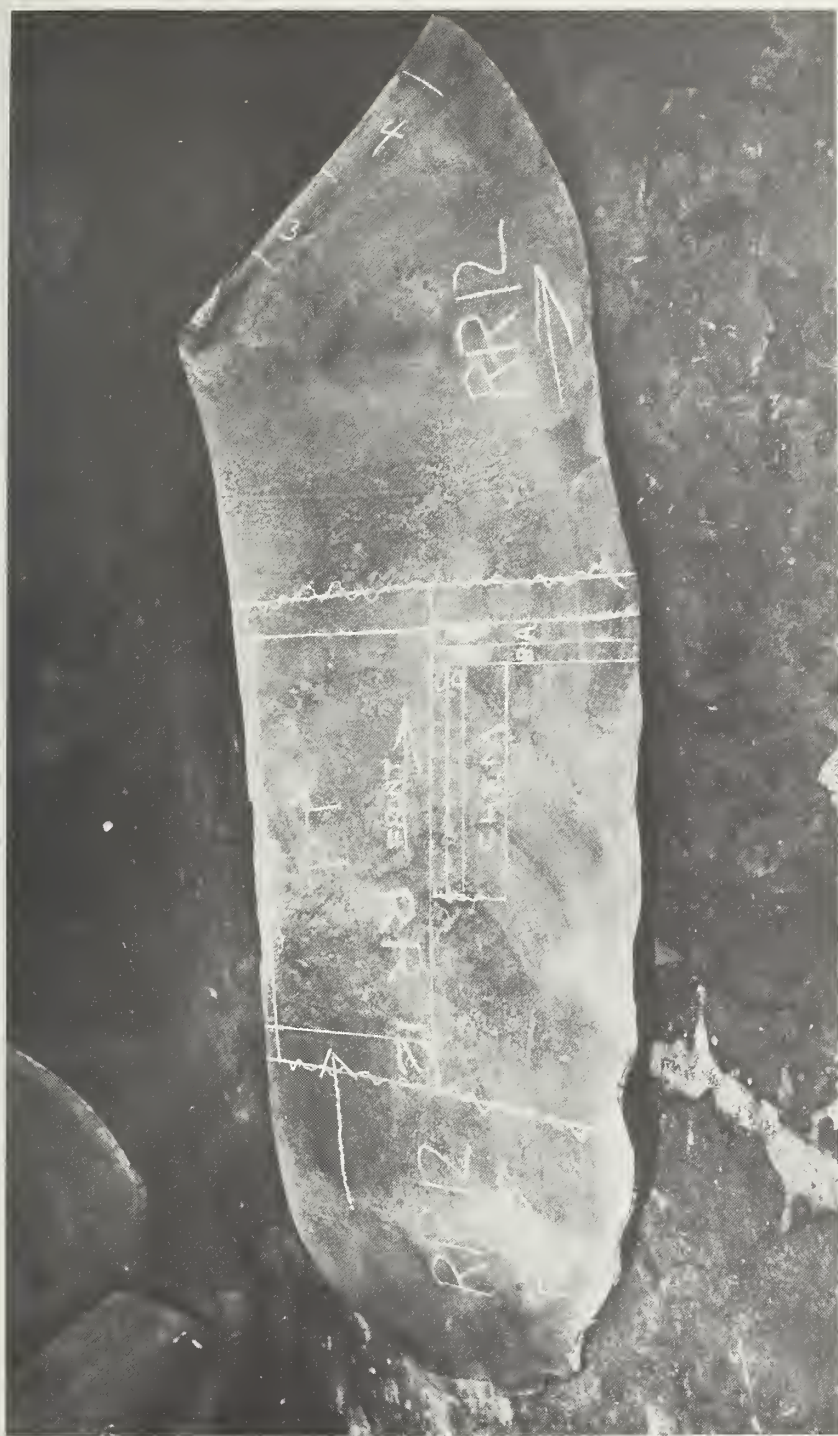
The edge of piece RR-12 containing the fracture origin appears in Figure 5. It is located along the fracture edge where the words "saw cut" appear upside down. One side of the fracture origin was removed from piece RR-12 by sawing along the "saw cut" line. The other side has been preserved intact on piece RR-16. Care was exercised in the sawing so that coolant from the band saw did not flow over the fracture surface. A heavy deposit of various products coated the entire fracture surface.

Figure 5. Inside wall of piece RR-12 showing location of specimen taken for chemical analysis. The arrows point in the longitudinal direction. This piece is about 30-inches wide by about 50-inches long. (Photo courtesy of M. Bolinger, Jr., Gladstone Laboratories, Inc., Cincinnati, Ohio.)

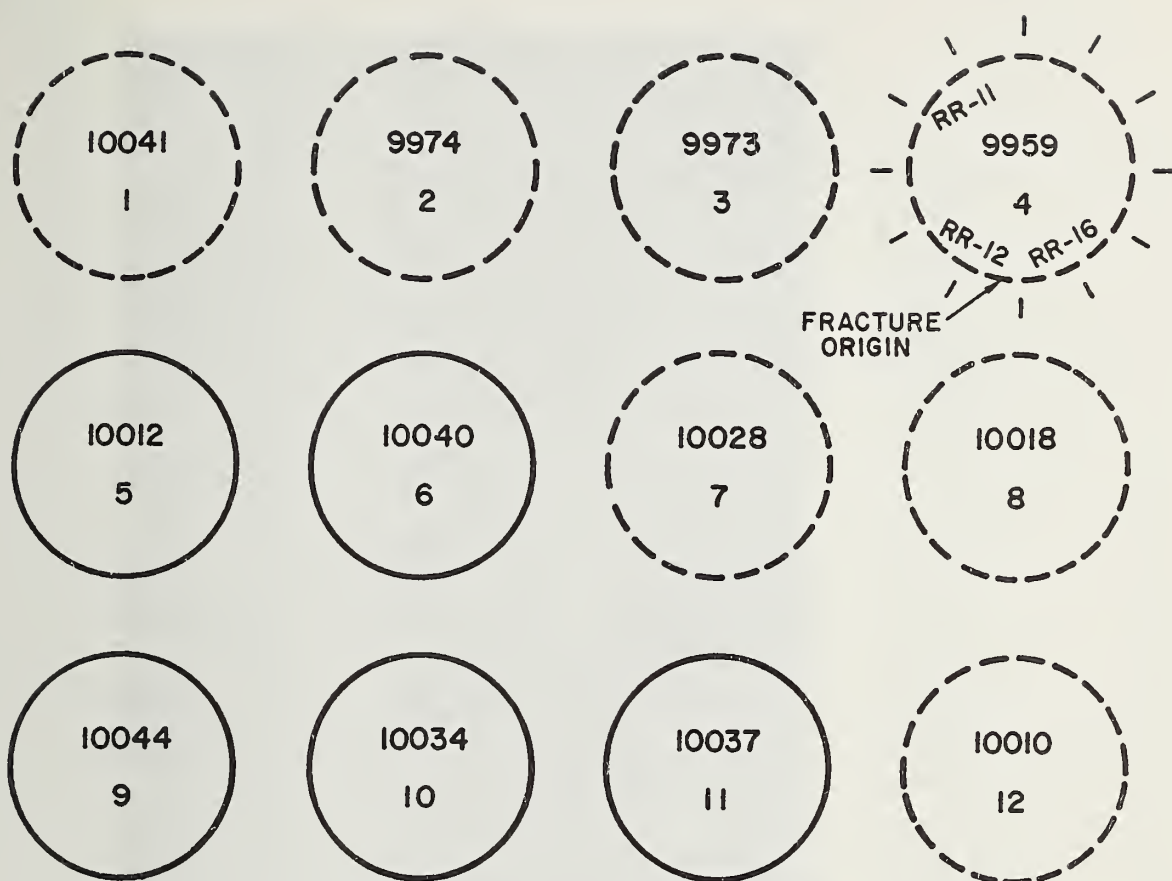
TUBE TRAILER T-256
(Viewed from rear)

The cylinder which ruptured was in the top row of a four-wide by three-high array of cylinders on the tube trailer. It was on the outside at the right, as viewed from the rear of the trailer, Figure 6. The serial number stamped in the cylinder is 9959. For convenient reference to positions of cylinders on the tube trailer, the cylinders are numbered 1 through 12, as shown in Figure 6. Thus, the cylinder which ruptured is also designated as cylinder 4.

The fracture origin was located in the sidewall of the cylindrical section. It was first identified by R. McCombs of the Gladstone Laboratories, and subsequently verified by B. W. Christ of the National Bureau of Standards and W. A. Maxey and T. Groeneveld of Battelle. It was about 12.5 feet from the front head, and between the 6 and 7 o'clock positions*, as shown in Figure 6. The fracture origin was between pieces RR-12 and RR-16.

Figure 6. Array of specification DOT-3T cylinders on tube trailer T-256 as viewed from the rear. The cylinder which ruptured is on the top row at the right. The location of the fracture origin is shown. It was 12.5 feet from the front head. The "RR- " designations assigned to the pieces near the fracture origin are indicated. (Identification number for each tube supplied by Jack B. Kelly Enterprises, Inc., Amarillo, Texas.)

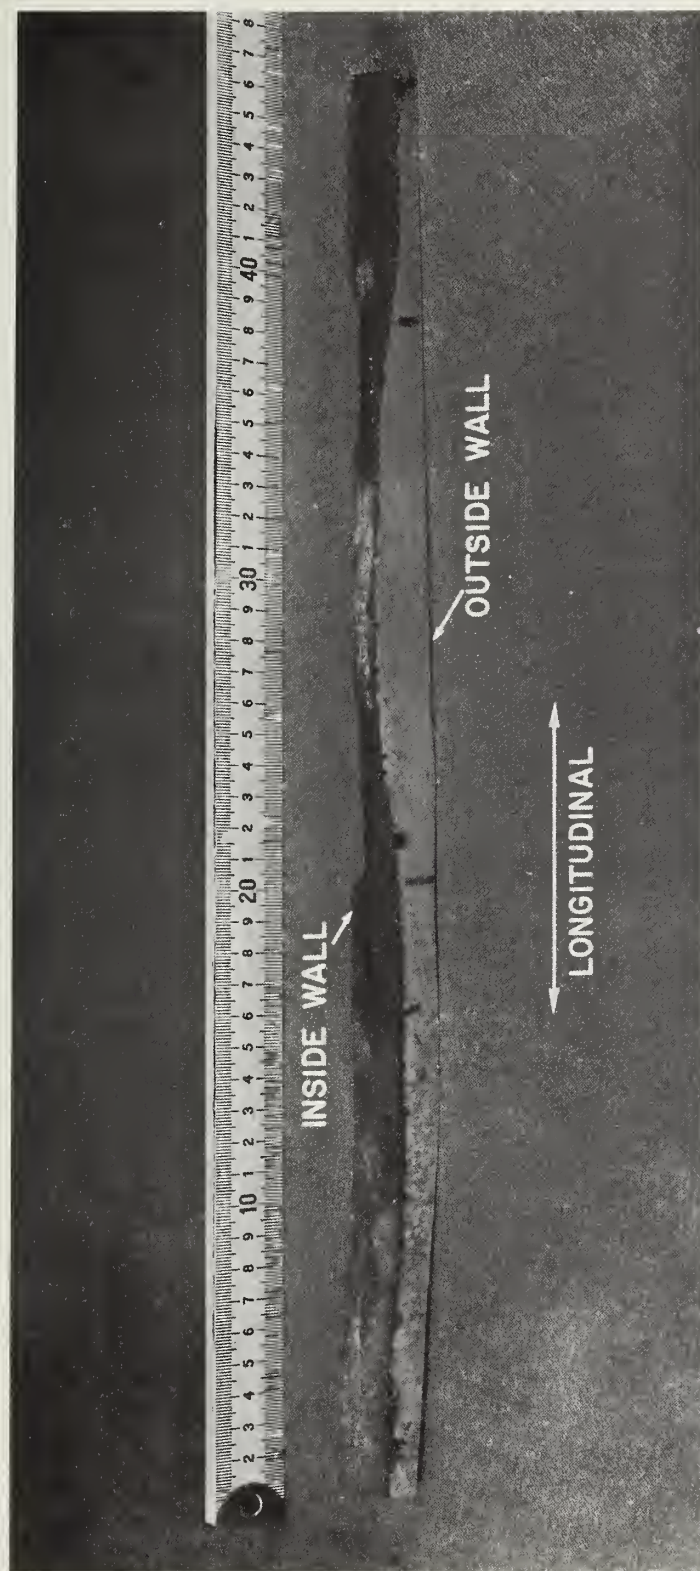
It is possible that the fracture origin was not a single crack, but rather, three cracks that linked up, as suggested in Figure 7. Figure 7a is an overall view of the 17-inch long segment sawed from RR-12. This segment was about 1/2-inch wide at one end and 3/4-inches wide at the other. The outside wall is facing the viewer in Figure 7a. A view directly down on the fracture origin appears in Figure 7b. Figure 7c is an artist's sketch clarifying Figure 7b and showing the position of the fracture origin on the 17-inch long segment. The step in the fracture origin between labels "1" and "2" is suggestive of 2 cracks. Yet a third crack is suggested by the asymmetry of the fracture origin in the region labeled "3".

Figure 7a. Seventeen-inch long segment cut from edge of piece RR-12 along the line labeled "saw cut" in Figure 5. The scale is in centimeters. The fracture origin is opposite "31" on the scale. The transition from flat fracture to full slant fracture occurs to either side of the fracture origin, between 20 and 39 on the scale.

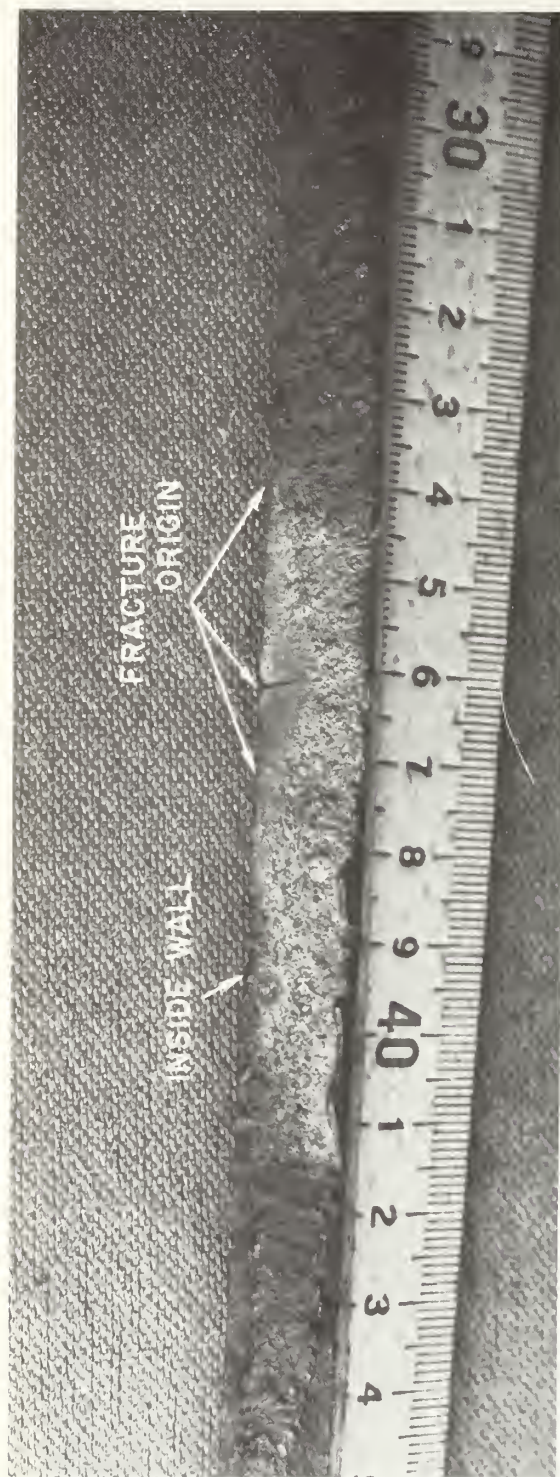
The fracture origin was a thumbnail-shaped part-through crack about 1.3-inches long and 0.25-inches deep. It reached from the inside wall to the mid-wall position. The long axis of the crack was approximately parallel to the longitudinal axis of the cylinder.

Figure 7b. View of fracture origin looking directly down on it. The scale is against the outside wall.

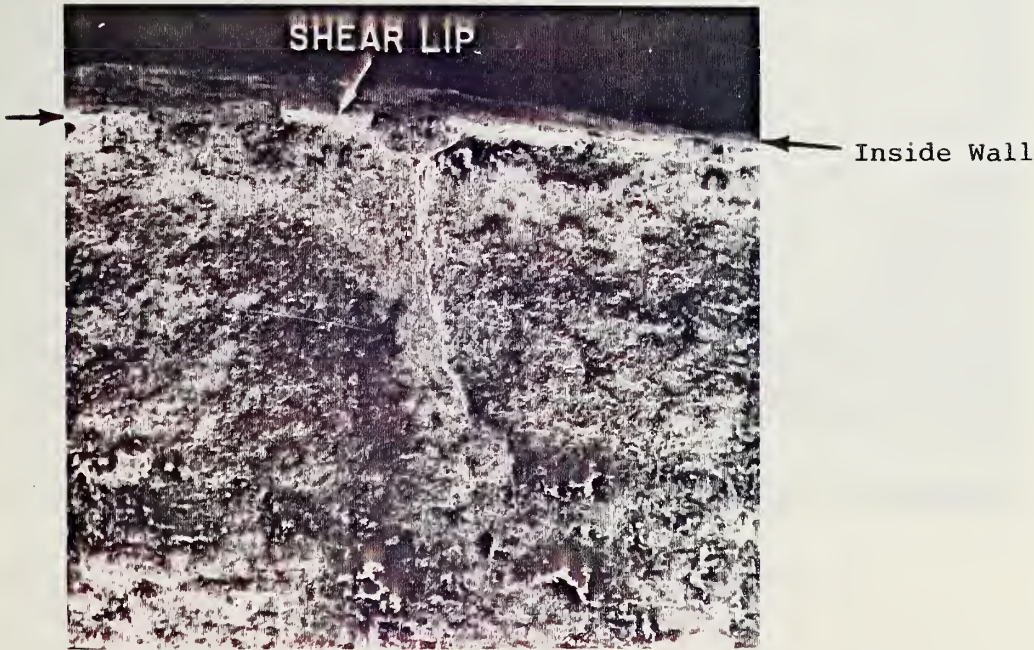
Figure 8b. Close-up view of step on fracture surface. Shear lips show up as intermittent white markings along inside wall. These shear lips are probably in the decarburized layer (see Section 5.3).

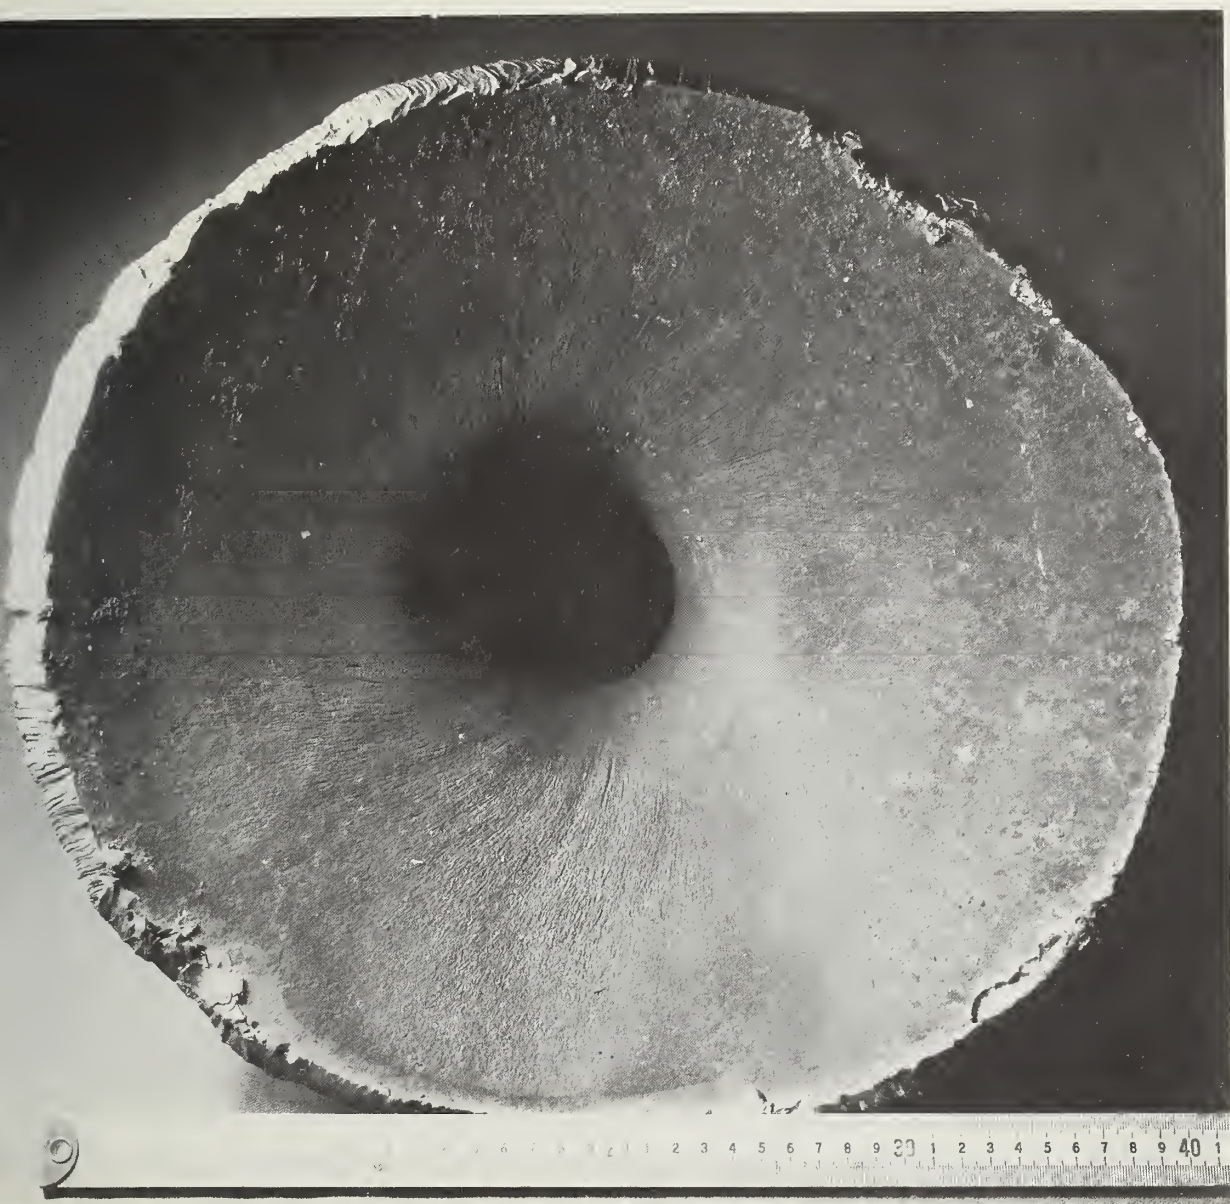
Near each head, the fracture path followed forging seams which formed from gathered metal that accumulated when the heads were forged, Figure 9a. Such forging seams were found at the heads of other

Figure 9a. Forging seams evident on inside wall at front head of cylinder 10041. The scale is in centimeters.

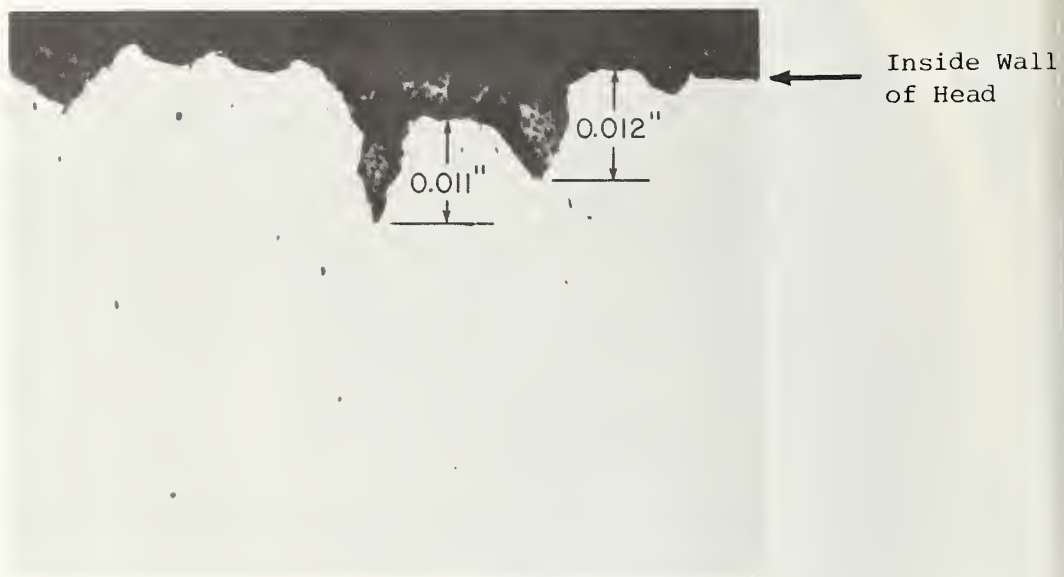
Figure 9b. Cross-section of typical forging seams found in front head of cylinder 10041.

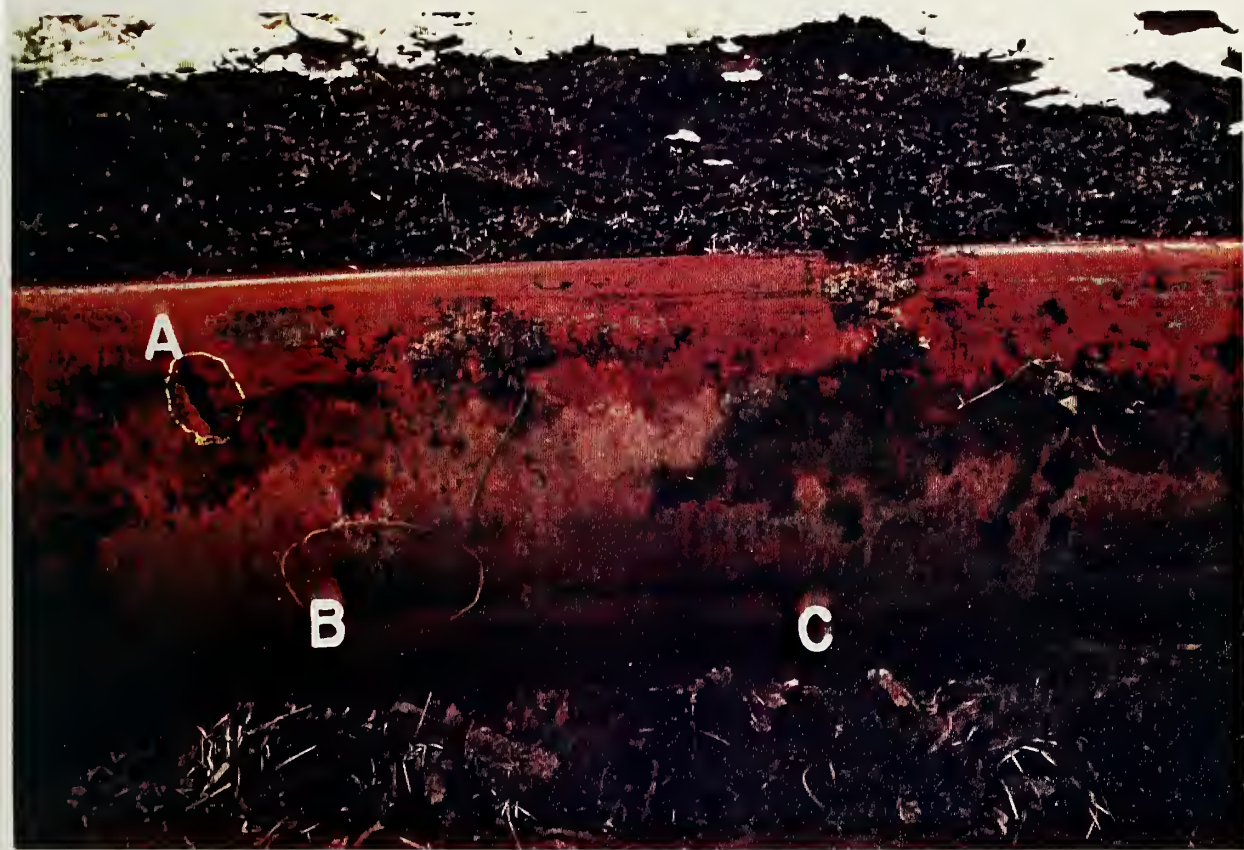
Figure 10a. Hit mark on cylinder number 8 (see Fig. 6 for location) made by opening flap of piece RR-16. The lines AB and BC in this figure correspond to the lines AB and BC in Figure 2b. The rear head of the cylinder is to the right.

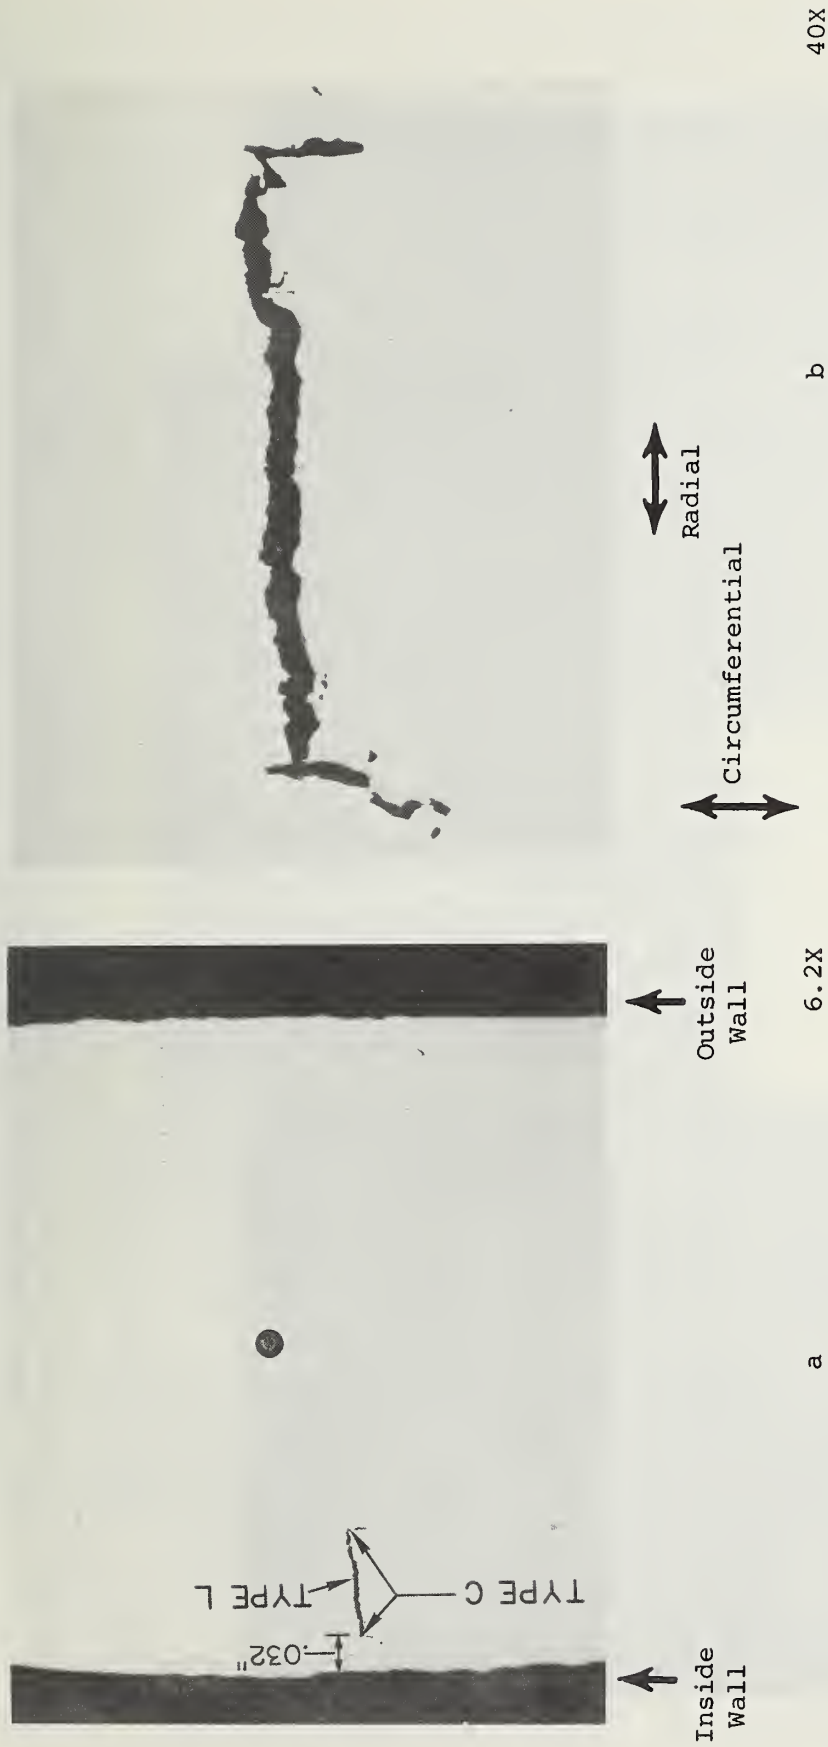
Figure 11. Type L and type C cracks detected in specimen TR-1. (See Figure 7c for specimen location.) The large black circle is a Rockwell C-scale hardness indentation. The row of tiny black dots is a series of Knoop microhardness indentations. (a) Transverse section showing full wall thickness. (b) Close-up view of the cracks.

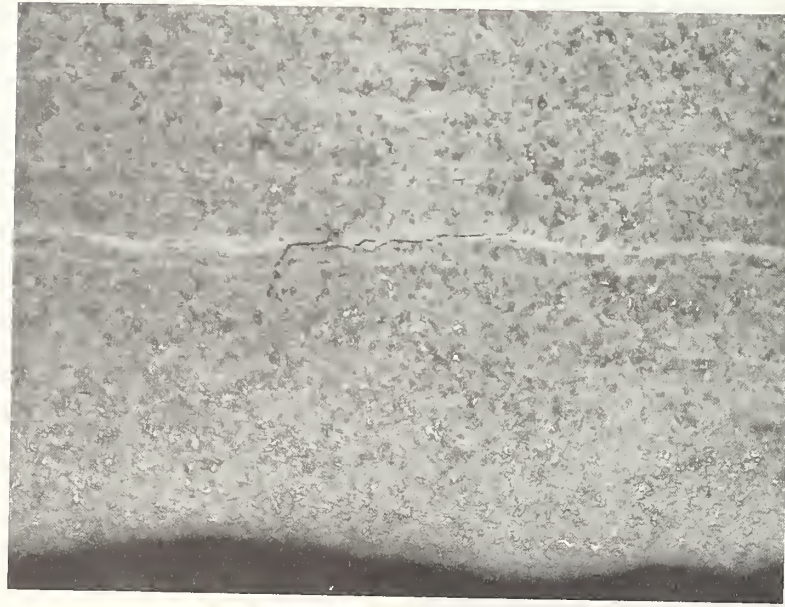
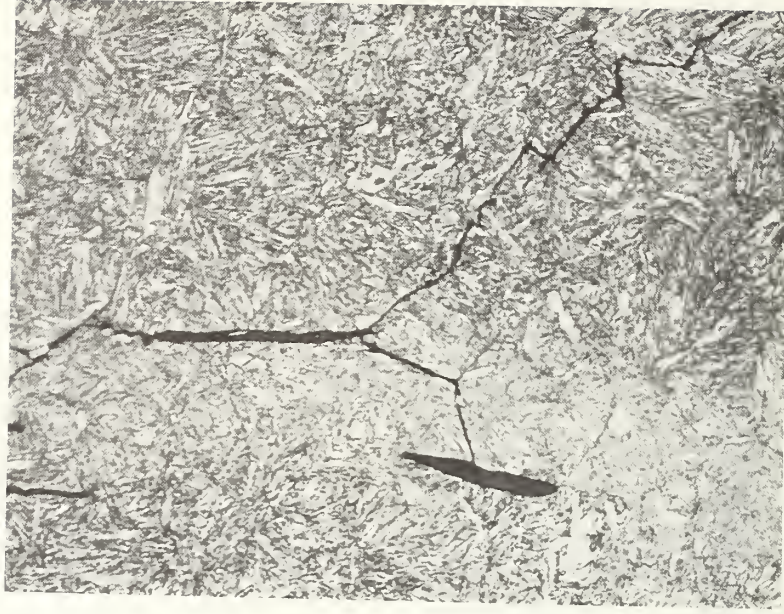
Figure 12. Intergranular crack path at tip of type C crack found in white-etching microzone specimen TR-6. (See Figure 7c for specimen location.) (a) Transverse section showing relationship of crack to inside wall. (b) Intergranular crack path developing at tip.

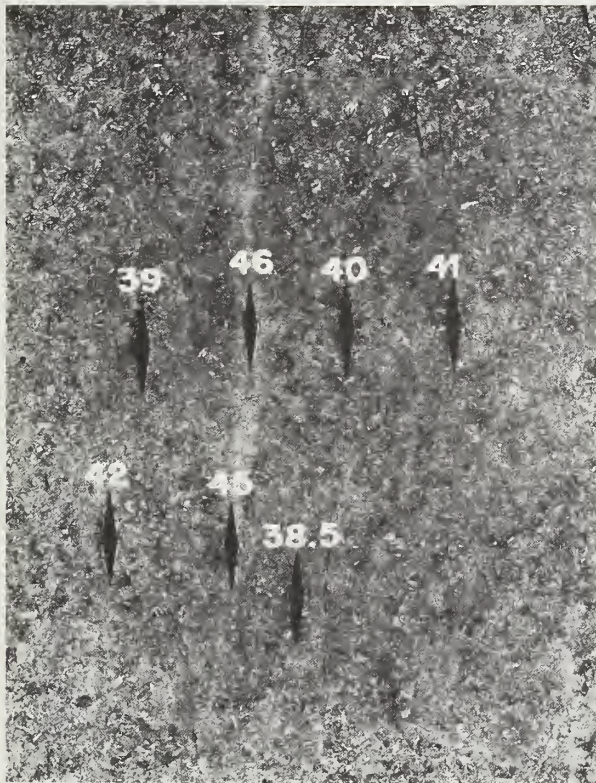
Figure 13. White-etching microzones found near inside wall in transverse specimen L. Rockwell C-scale hardness equivalents are shown. (see Figure 7c for specimen location.)

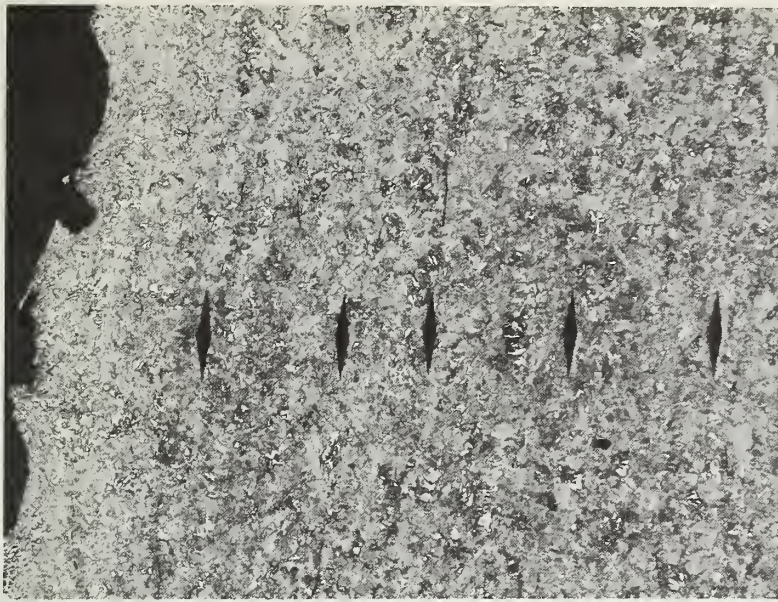
Figure 14. Banding near inside wall detected in transverse section taken from a ring cut near the front head of cylinder 10041.

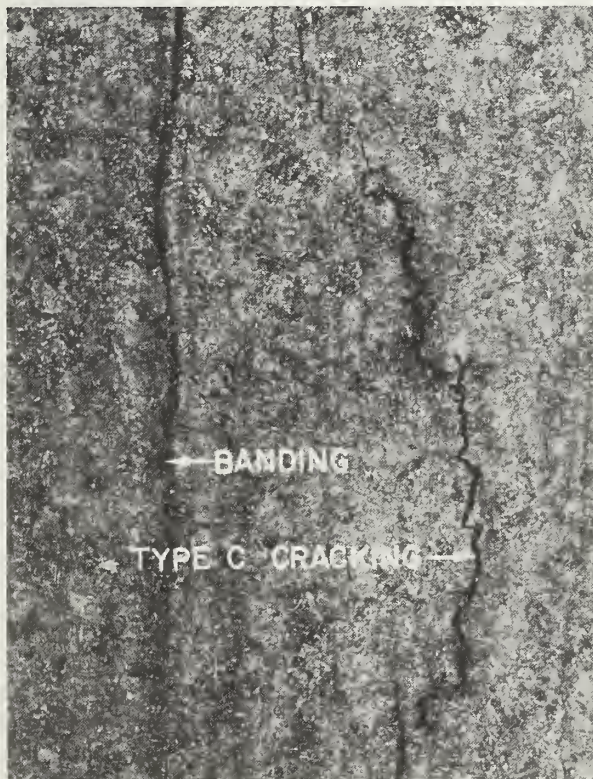
Figure 15. Cracking parallel to banding and inclusions in an unstressed transverse section of a test specimen saturated with diffusible hydrogen in the laboratory. This specimen was taken from a ring cut near the front head of cylinder 10041.

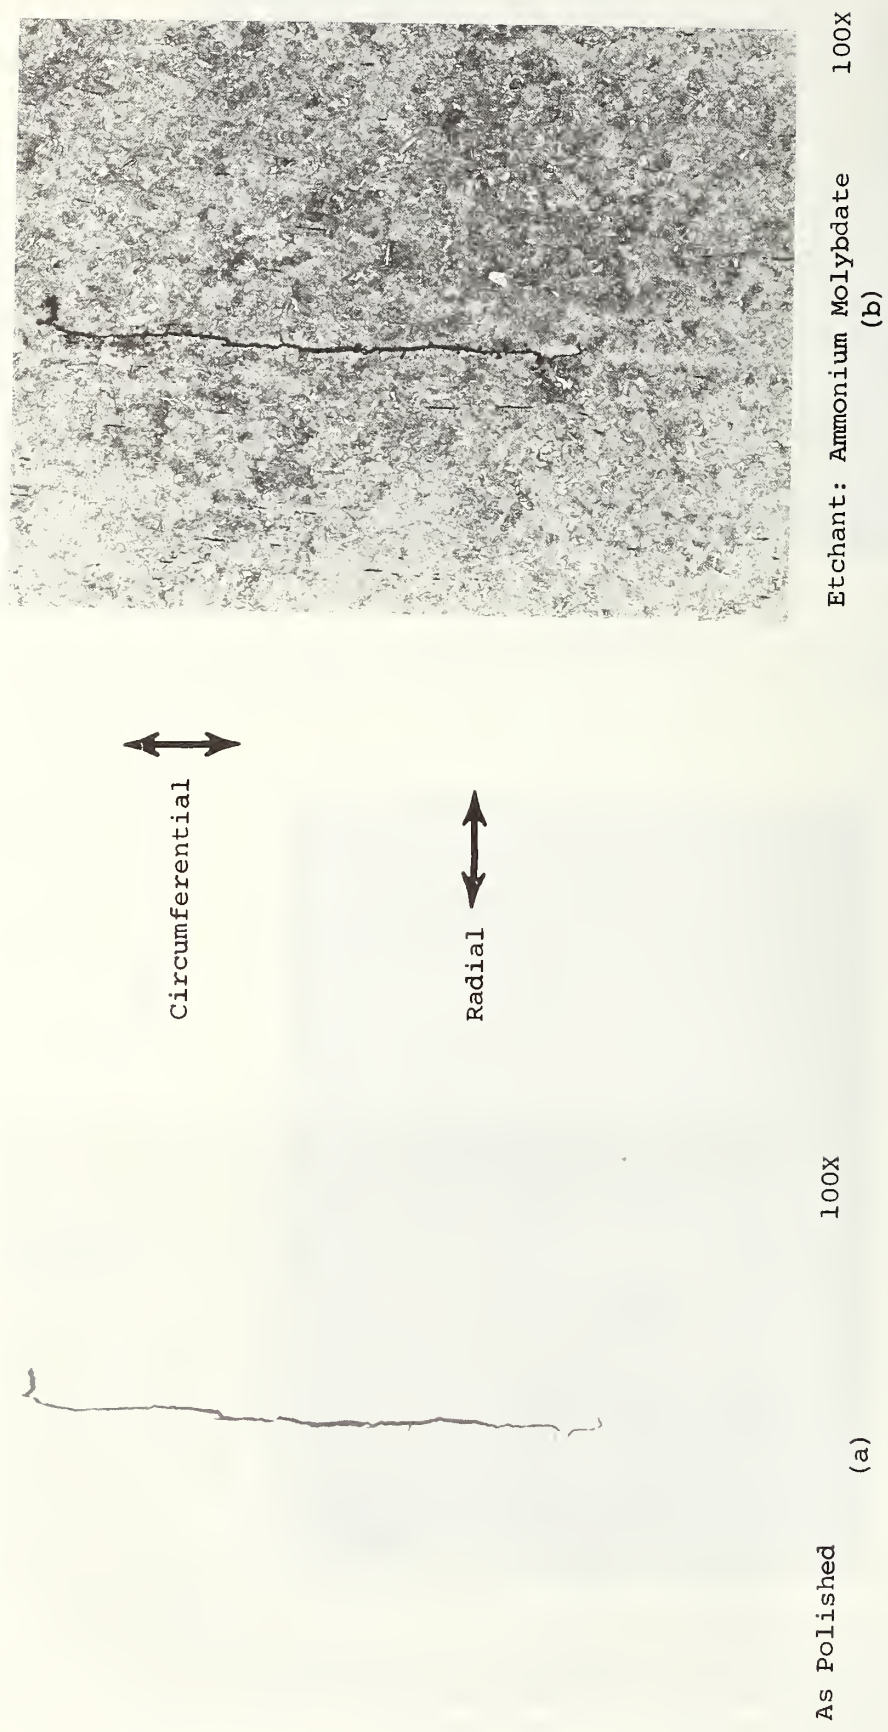
Figure 16. Incipient type L cracks which appear to have originated at radial jogs in a type C crack. This cracking was found in specimen TR-5. (a) As polished section showing cracks, (b) Same section as in 16a after etching with ammonium molybdate.

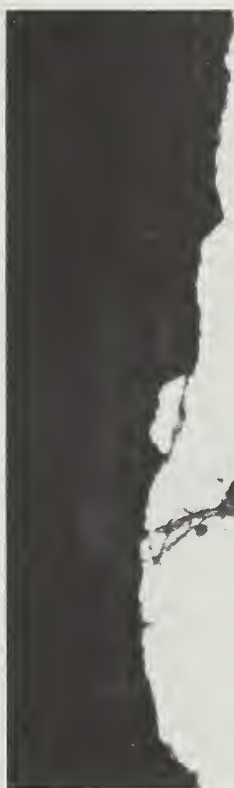
Figure 17. Surface lap detected near inside wall of cylinder 10041.

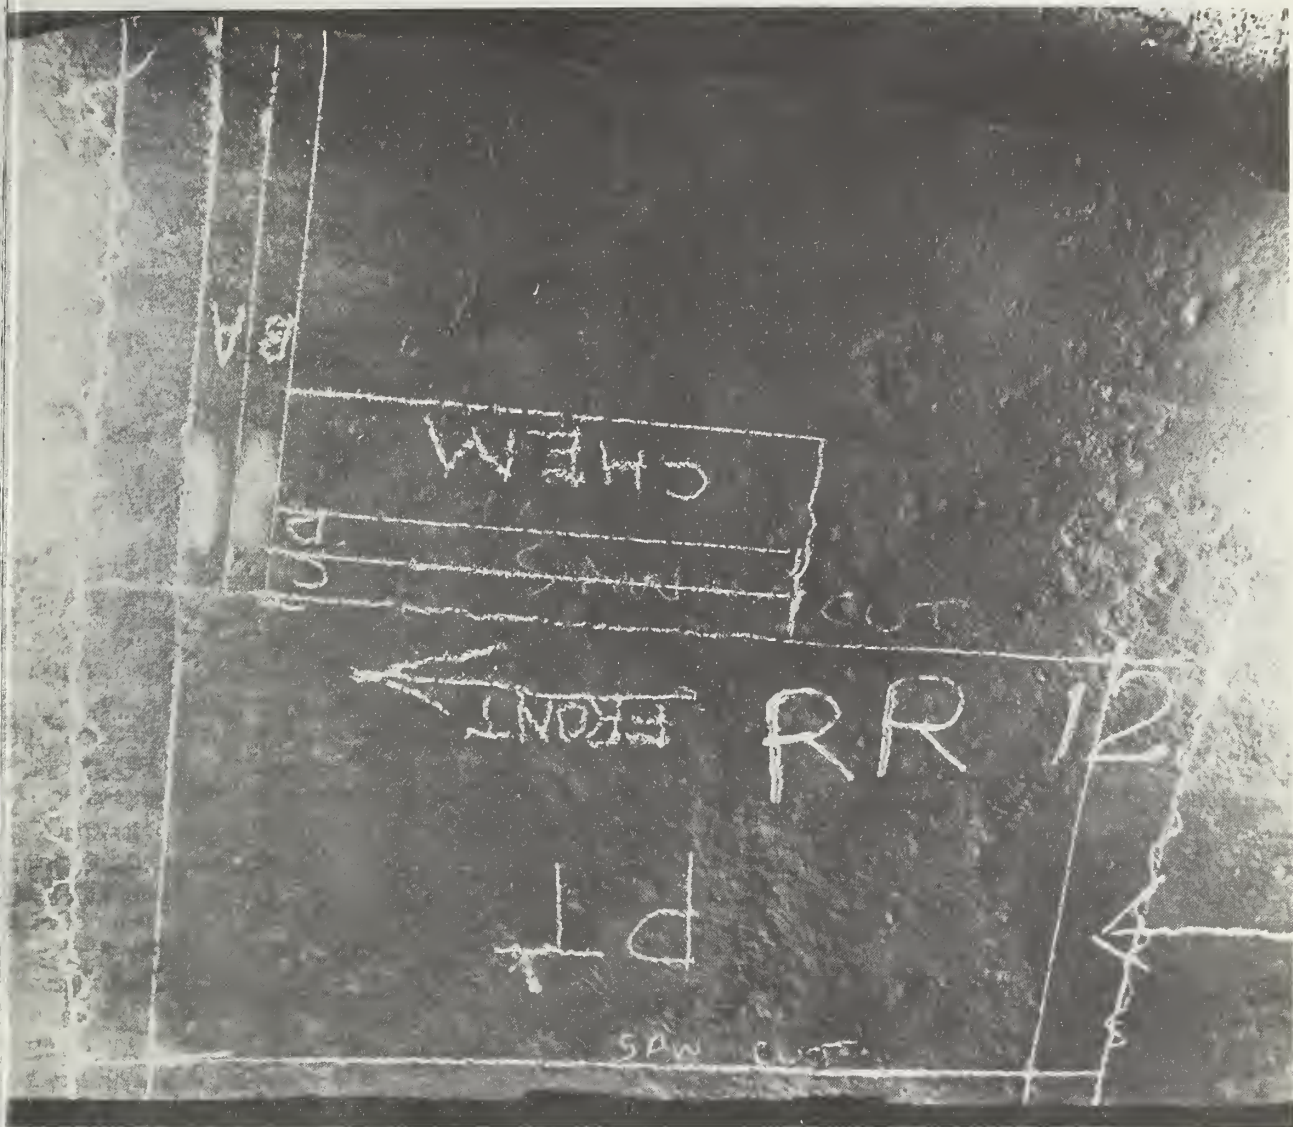
Figure 18a. A portion of piece RR-12 showing the general surface topography of the inside wall near the fracture origin. The fracture origin is along the bottom near the words "saw cut." (Photo courtesy of M. Bolinger, Jr., Gladstone Laboratories, Inc., Cincinnati, Ohio.)

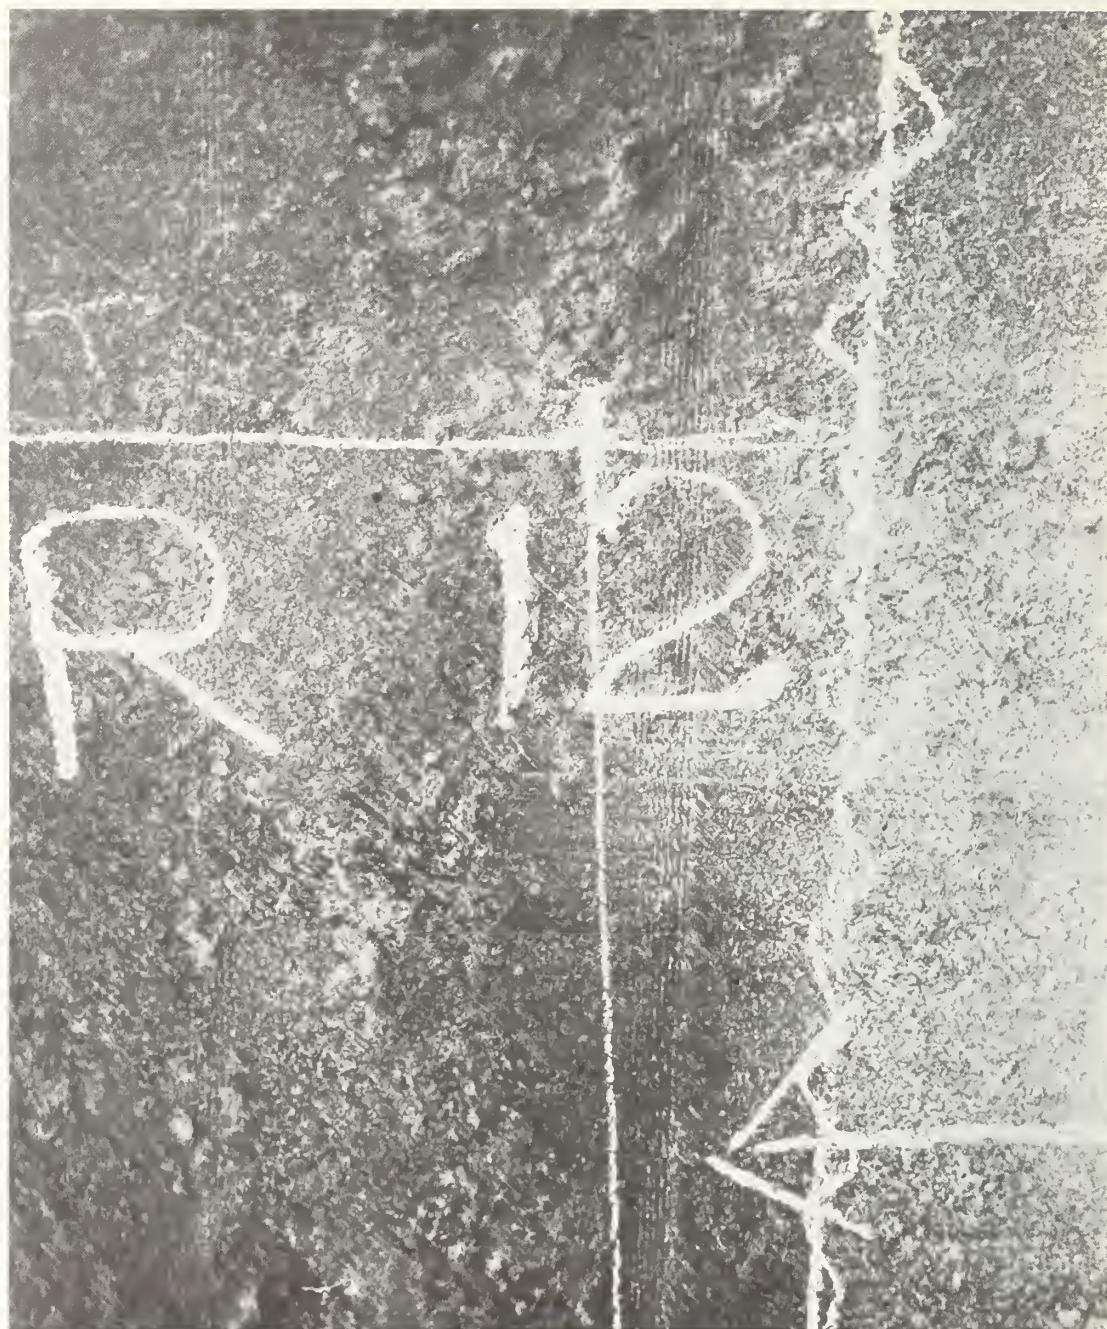
Figure 18b. A view of piece RR-12 showing sets of parallel lines running in the circumferential direction. (Photo courtesy of M. Bolinger, Jr., Gladstone Laboratories, Inc., Cincinnati, Ohio.)

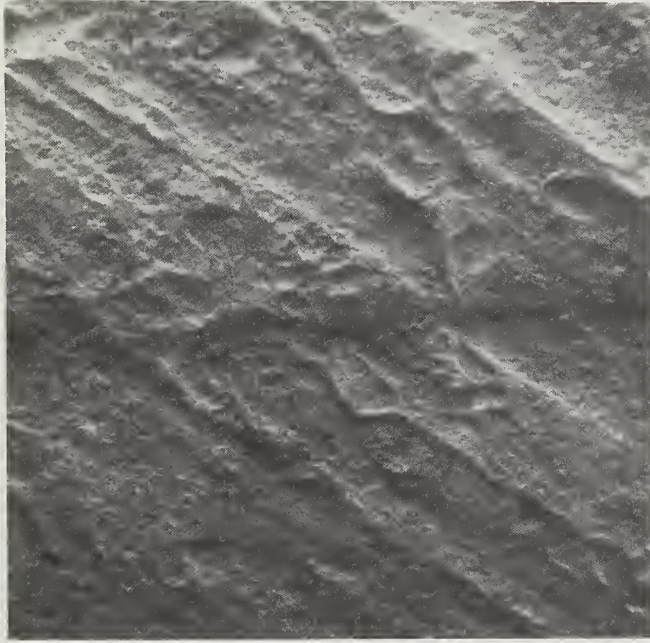
Figure 19. Surface topography of the inside wall of specimen TR-1 near the fracture origin after solution cleaning, showing craters and grinding scratches. (Photo obtained in scanning electron microscope.)
